AMP 300 FM MOSFET REPLACEMENT

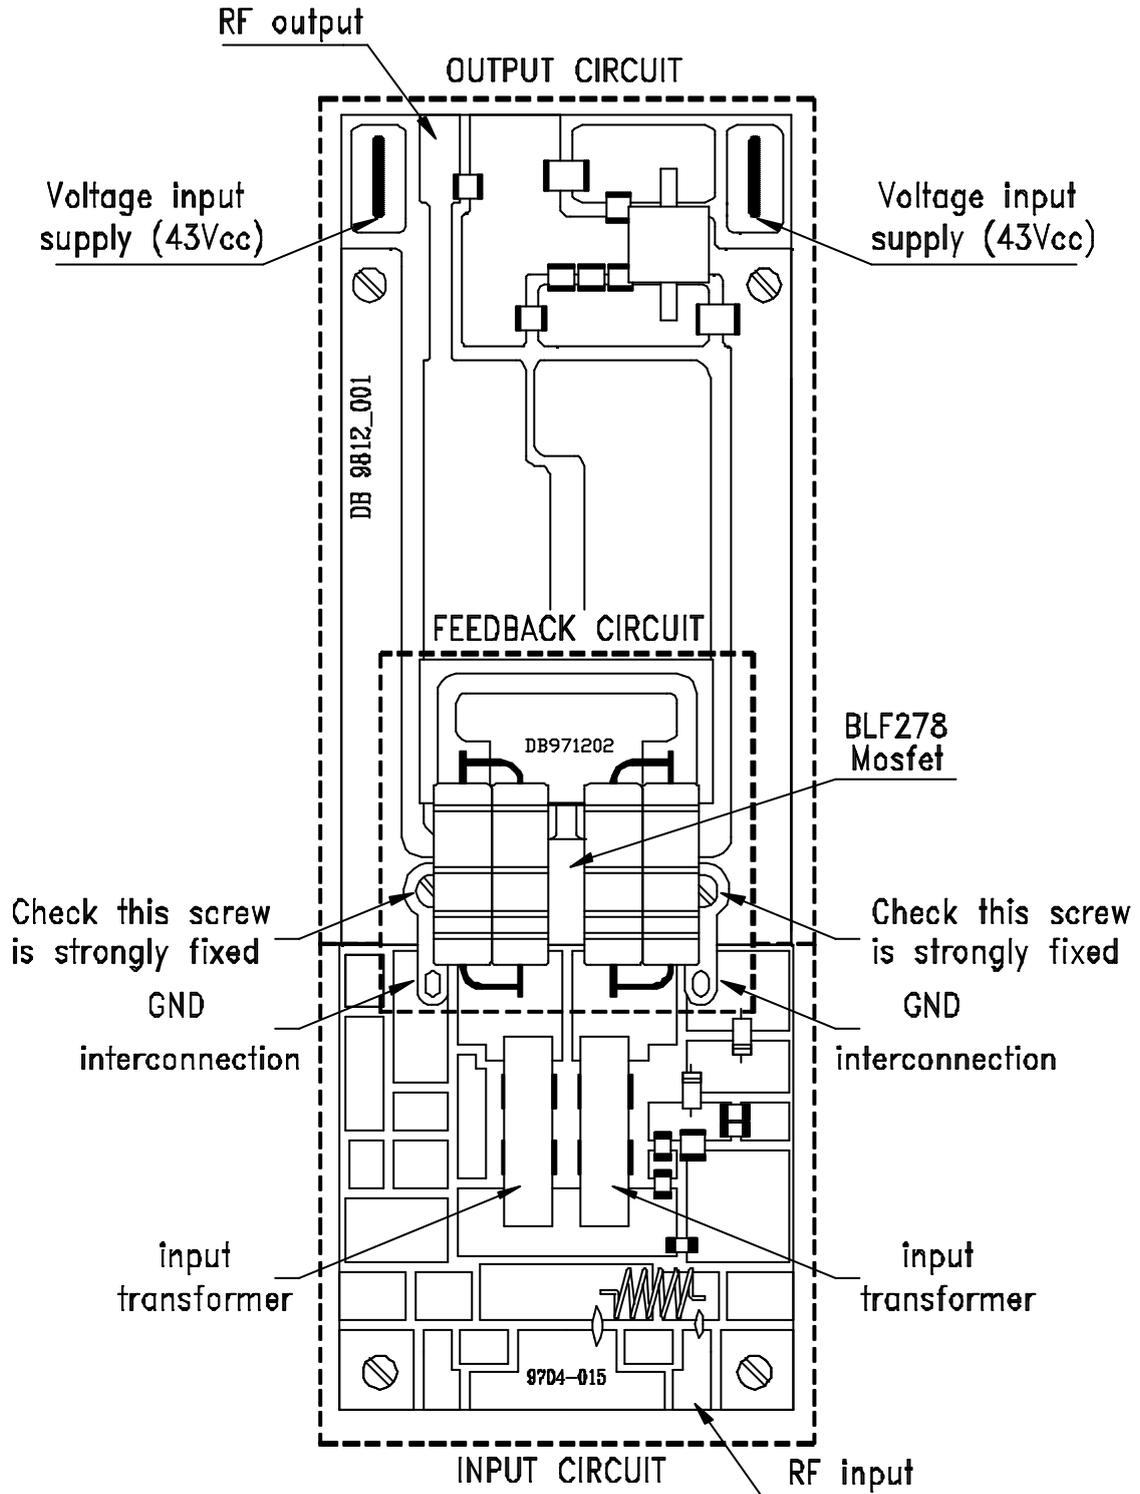
MOSFET REPLACEMENT

- 6) Put on the thermally conductive compound between the MOSFET case and the heat sink.
- 7) Fix the MOSFET to the heat sink (screws must be strongly fixed) and solder all the four pins of the MOSFET: **pay attention to the output board soldering because an excessive quantity of tin can cause a short circuit between different board layers.** Reconnect also the 2 GND interconnections, indicated on the next picture, and check the right soldering of the input transformer and gate resistor.

- 11) In case the replaced MOSFET doesn't reach the nominal output power or in case of spurious emissions you need to improve the input matching of the MOSFET: to do this compress or expand manually the input circuit coil (see next picture) to maximize the output power.
